ADVANCED METALLIC AIR VEHICLE STRUCTURE PROGRAM

GENERAL DYNAMICS
FORT WORTH DIVISION

JUNE 1975

FOURTH INTERIM REPORT ✓
TECHNICAL REPORT AFFDL-TR-75-40

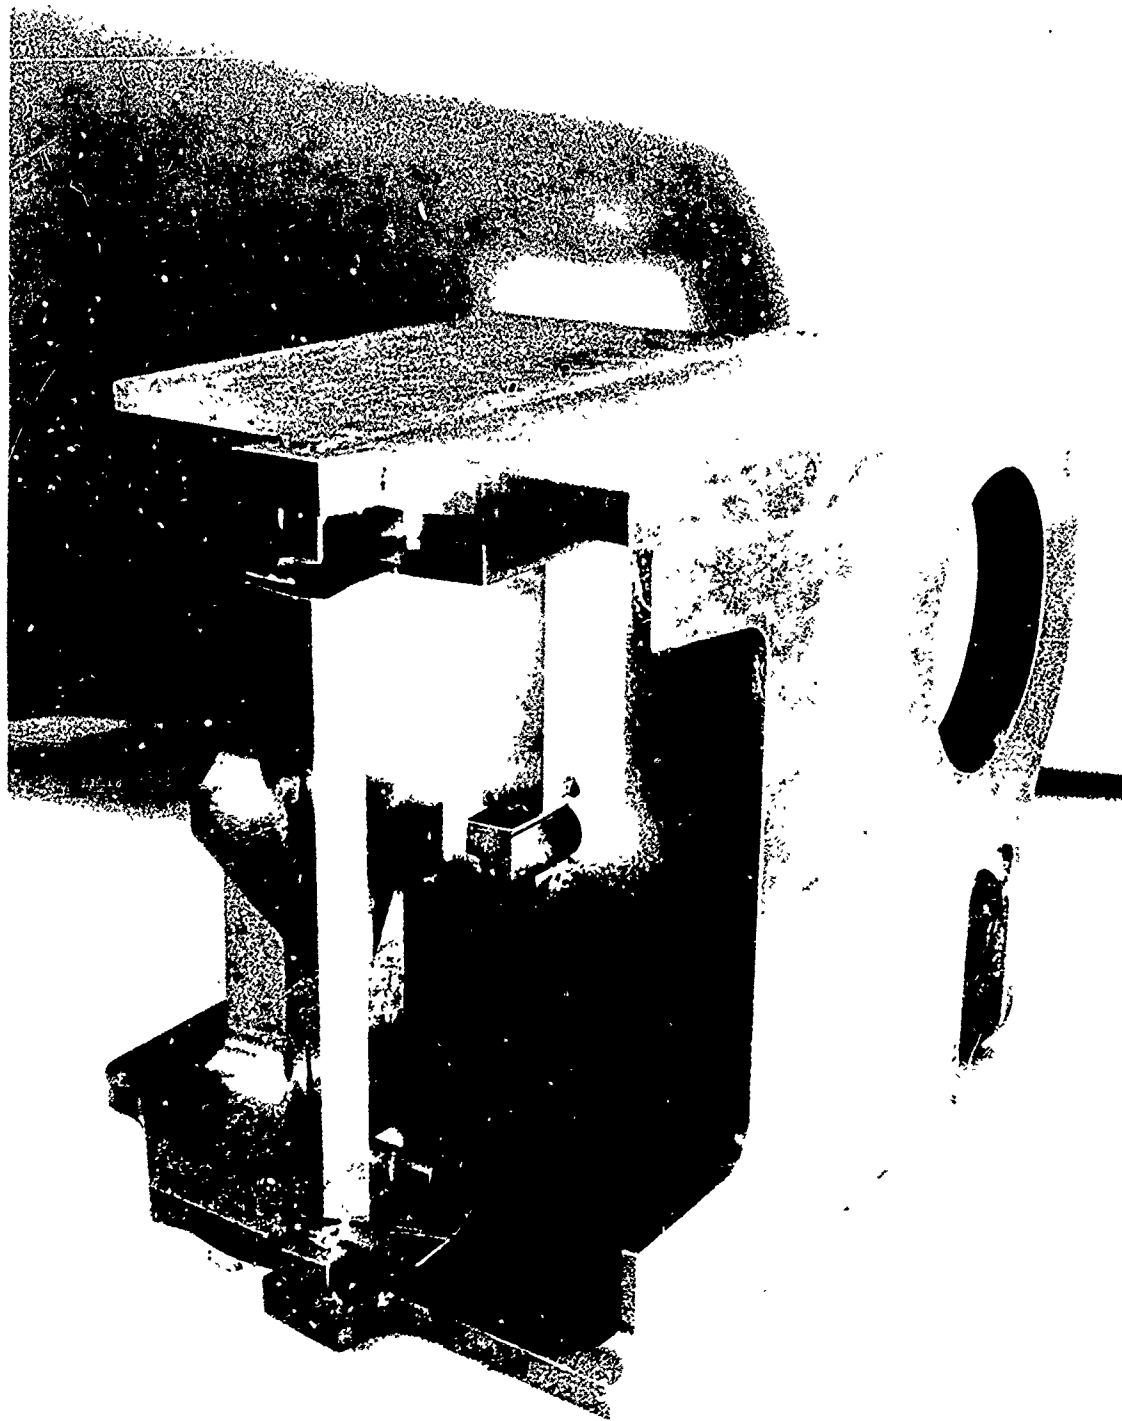
Figure 5.1.2-19 LOWER WELDMENT - MLG SIDE BRACE FITTING

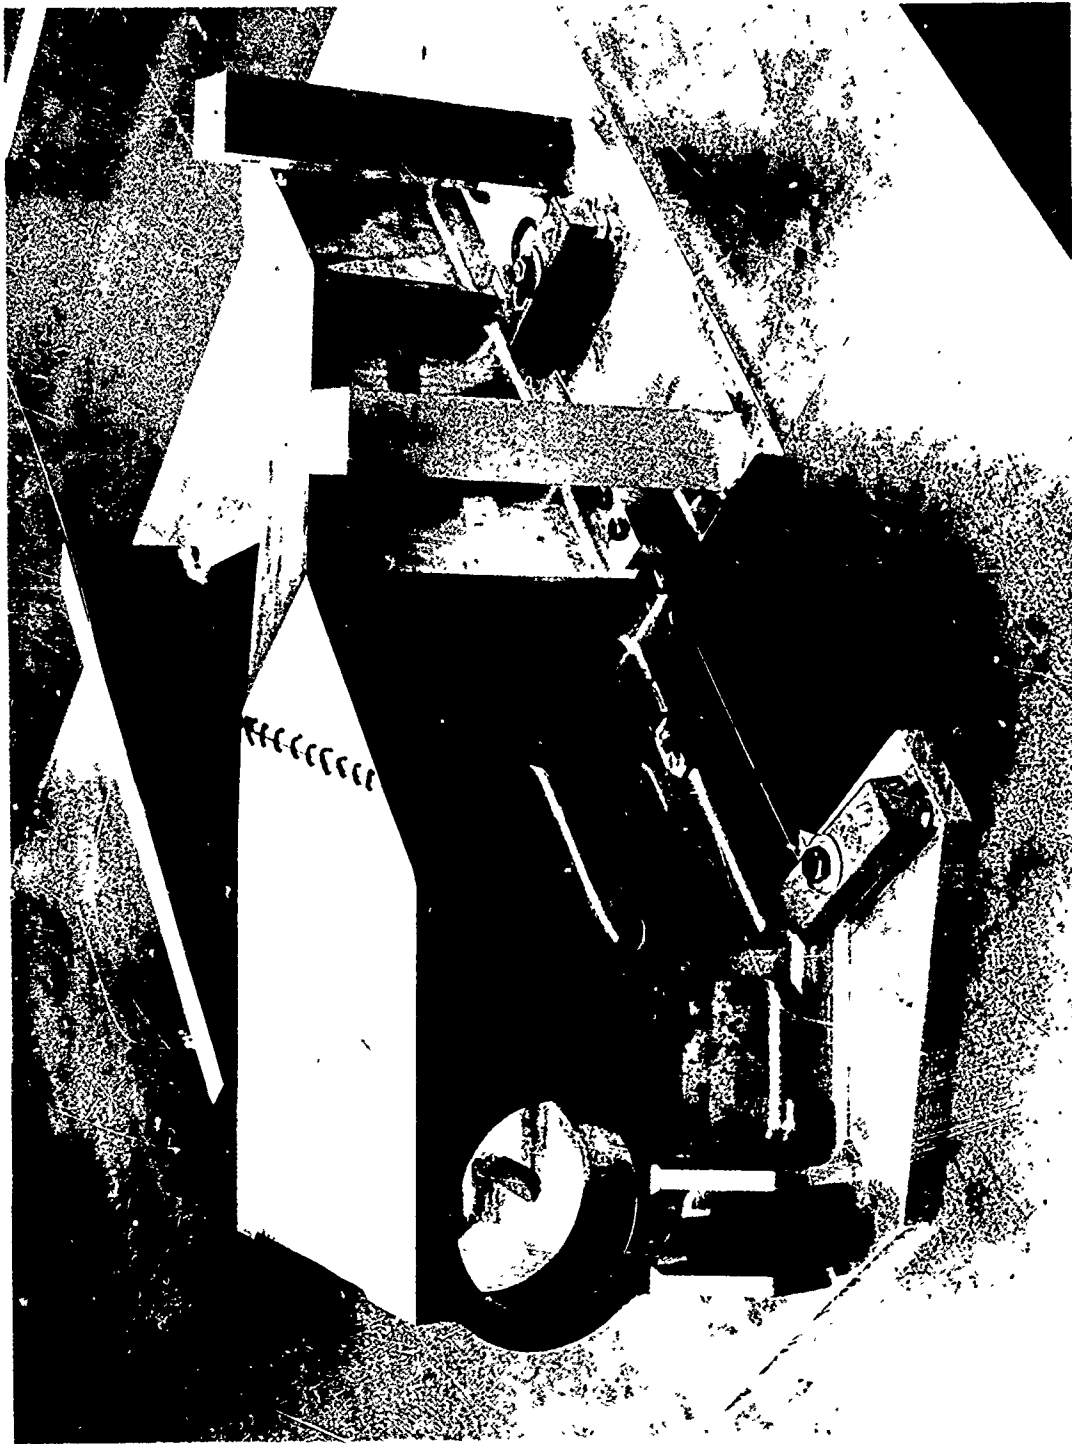
Figure 5.1.2-20 MAIN LANDING GEAR SIDE BRACE FITTING
FINAL WELD

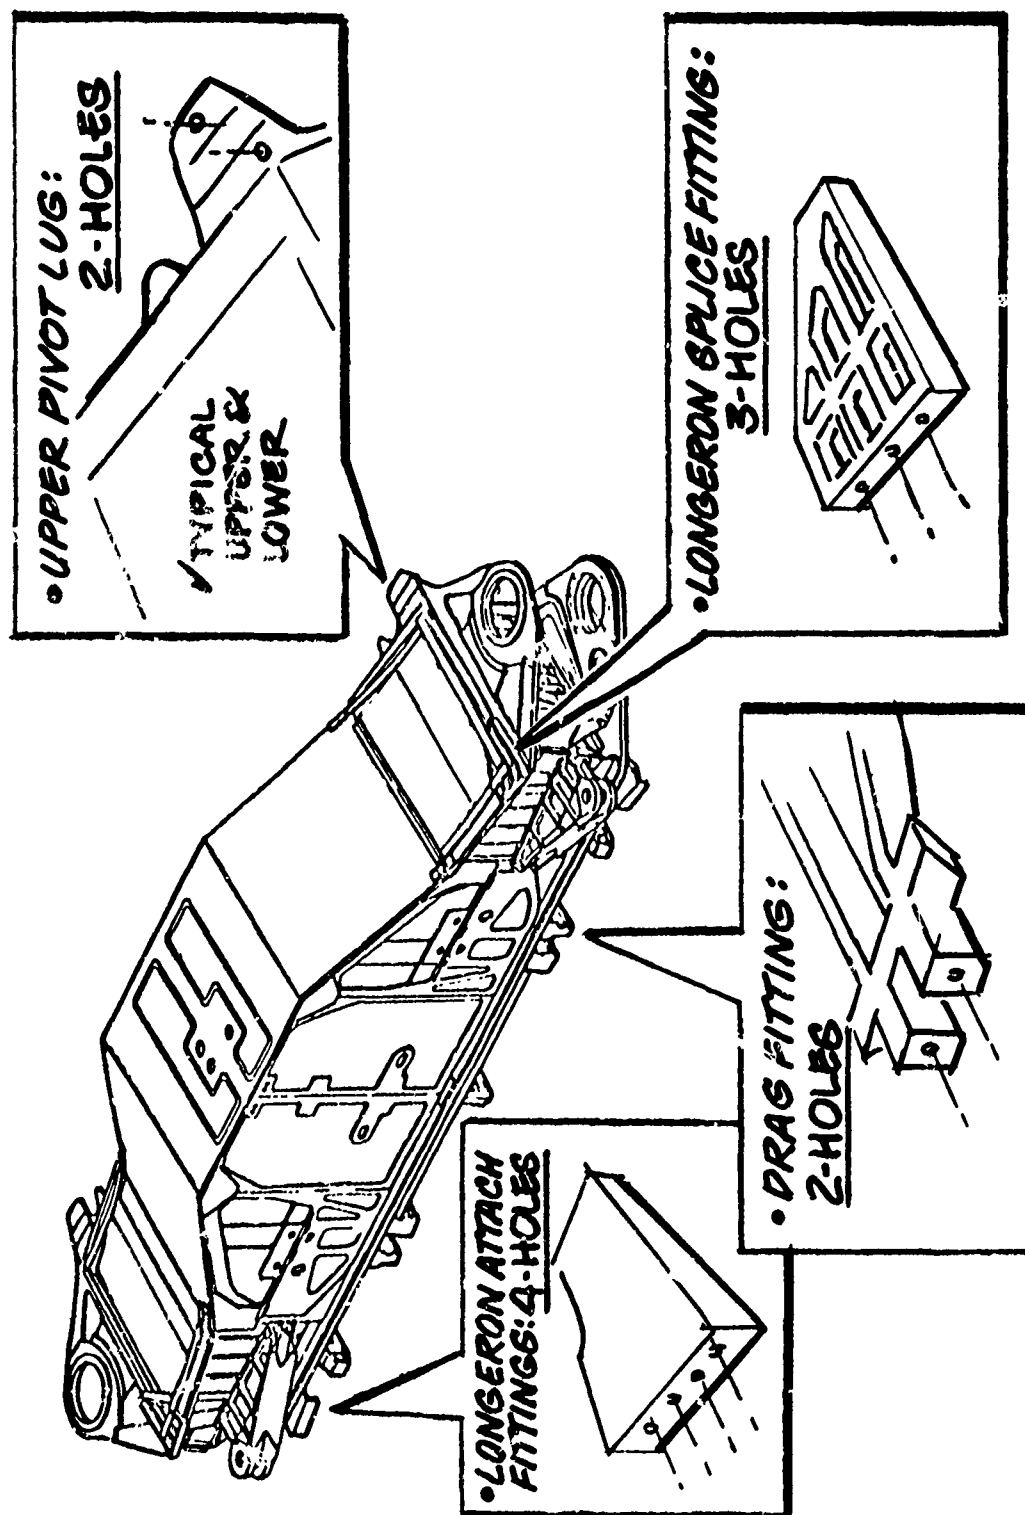
Figure 5.1.2-21 DRILL FORWARD LONGERON ATTACH FITTINGS
